**Shoring and reinforcement
in emergency disaster situations**

Dissertation to obtain the Master Degree in
Military Engineering

October, 2014

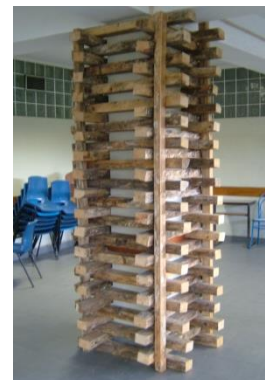
Figure 5 – Cribbing [Photos transferred by RSB]

The cribbing system, presented in Figure 5, allows adjusting the height of the element being shored, varying the number of pieces per layer and the height of each piece. It can also be adopted for inclined elements if wedges are applied between layers. This system is evidenced in FEMA, SOG, *Manual de Salvamento Terrestre* and Spanish emergency manual.

The left figure shows a strengthening possibility, that applies a system of wrapping with polyester strapping, similar to the one shown in Figure 12 of the Manual STOP. On the other hand, if the pillar presented no resistance, a wood shoring system as shown in Figure 5 would be recommended, for being self-supporting, assuring the transmission of loads even in the event of a collapse of the pillar.

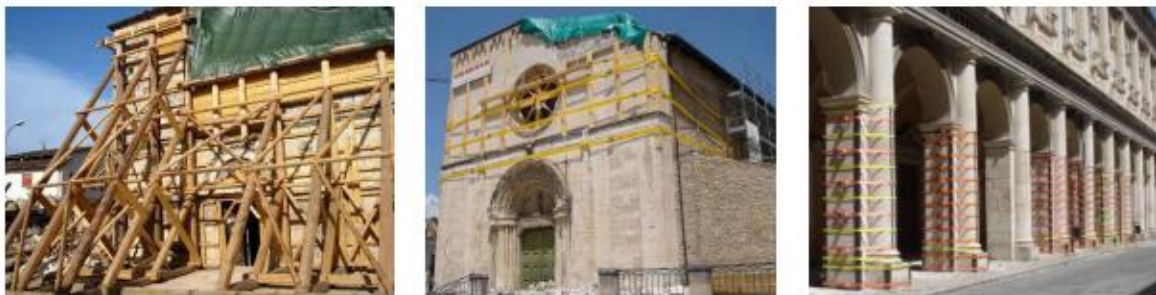
Figure 14 - Temporary consolidation procedures [9]

In Figure 14 are visible three types of interventions, all applied to stone masonry buildings (two churches and a large public building), the first with a diagonal strut, the second with an overall wrapping of an area of the building and the third with a wrap of columns in a system of arches outside of the building, through strapping of polymeric bonds, allowing a very quick implementation.

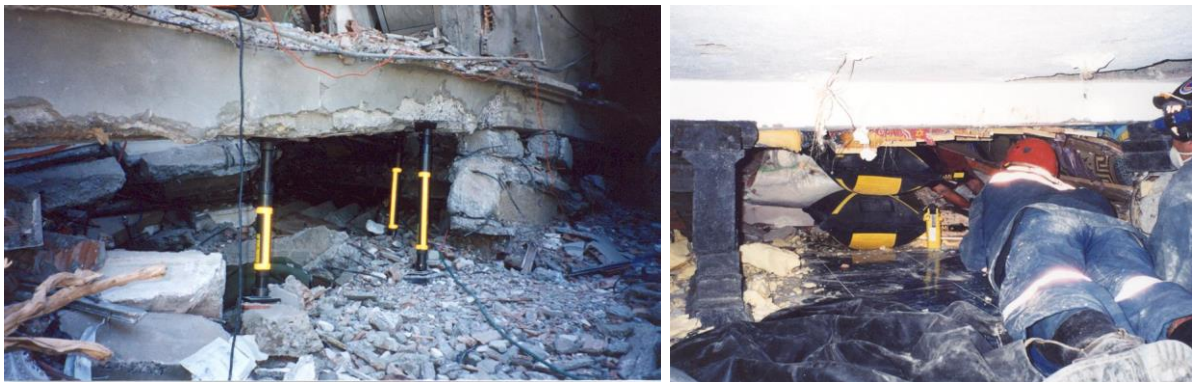
Figure 16 - The RSB in Algeria [Source: Photographs kindly supplied by RSB]

In the left figure it is possible to see the implementation of three braces to support the rubble of the building and create a tunnel, allowing the advancing to the place where the victim is. On the other hand, the right picture shows the exact location of a rescue operation, where it is possible to see the application of blocks and pillows.

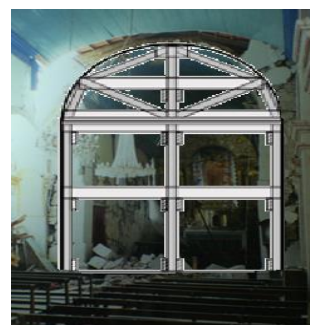
Figure 17 - Solution for shoring of arch

Figure 17 shows a possible solution to this type of shoring, which would allow the support the loads that were transmitted to the arch also contributing to restore support and capacity of resistance in the transverse direction of the church. This solution is the same that is presented in Figure 10, from the SOG Manual.

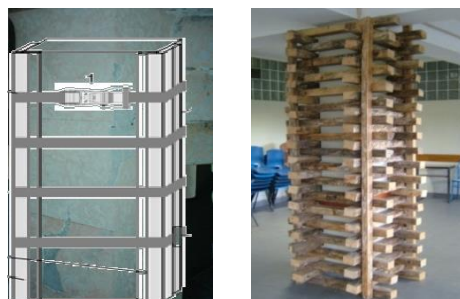
Figure 18 - Solutions of shoring and B-pillar reinforcement

In Figure 18 it is possible to observe the damage of a square masonry pillar that, as several others in the same church, was highly fissured, in a situation of pre-collapse by rupture by compression. In figure 18 two systems of shoring and strengthening are recommended.

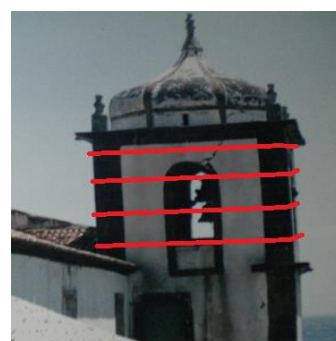
Figure 19 - Solution wrap the tower

The Church of São João, in the Pico Island, revealed major structural damage and relatively extensive, mainly in the tower with large diagonal cracking and the corners denoting outward displacements. The recommended procedure would be the wrapping of the church tower. Polyester strapping, shown in Figure 19, would provide containment to the constituent elements of the tower.
